DEPARTMENT OF TRANSPORTATION

Quality Assurance and Source Inspection

Contract #: 04-0120F4Cty: SF/ALA Rte: 80 PM: 13.2/13.9File #: 69.15**SOURCE INSPECTION REPORT****Resident Engineer:**Siegenthaler, Peter**Address:** 333 Burma Road**City:** Oakland, CA 94607**Report No:** SIR-003523**Date Inspected:** 22-Jul-2011**Project Name:** SAS Superstructure**OSM Arrival Time:** 700**Prime Contractor:** American Bridge/Fluor Enterprises, a JV**OSM Departure Time:** 1900**Contractor:** Zhenhua Port Machinery Company, Ltd (ZPMC), Changxing Island **Location:** Shanghai, China**Quality Control Contact:** Sun Xiong**Quality Control Present:** Yes No**Material transfer:** Yes No N/A**Sampled Items:** Yes No N/A**Stock Transfer:** Yes No N/A**OK to Cut:** Yes No N/A**Rebar Test Witness:** Yes No N/A**Delayed/Cancelled:** Yes No N/A**Other:****Bridge No:** 34-0006**Component:** OBG Component**Bid Item:****Lot No:** B-278**Summary of Items Observed:**

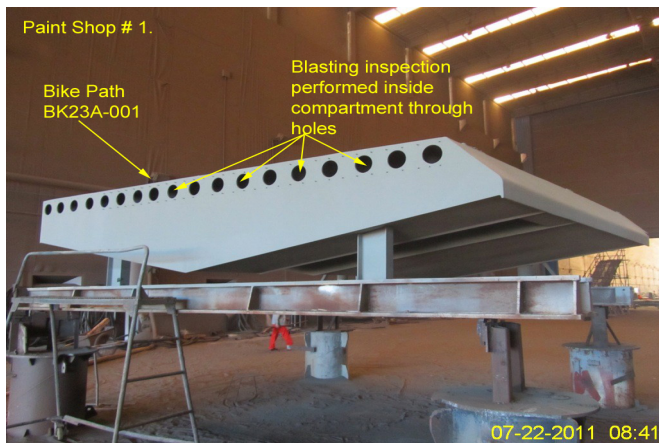
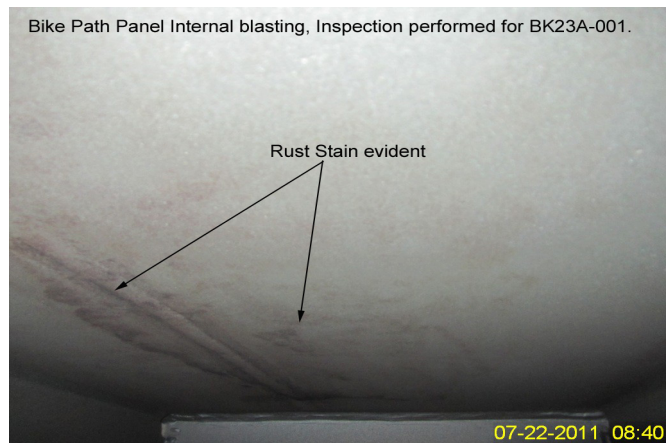
Bike Path Brackets BK23A-001.

Inspection Conclusions: Rejected as blasting was not meeting the requirement of specification by ABF QA and Caltrans QA concurred with the ABF QA's Inspection.
